JANUARY 1978 THE NAVAL AVIATION SAFETY REVIEW

PICK THE RIGHT ONE!

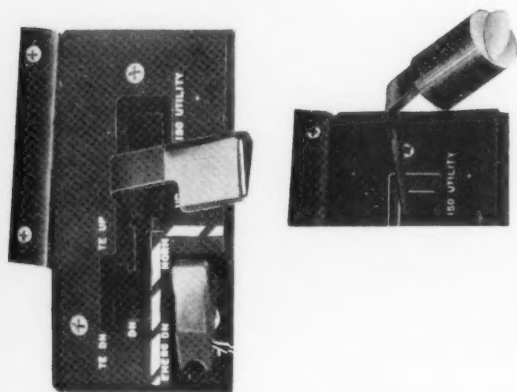
Fig. 1

In the A-7, the flap handle does considerably more than merely raise and lower the trailing and leading edge flaps. As shown in Fig. 1, the flap handle panel includes an ISO UTILITY position in addition to flaps UP and DOWN detents. Placing the flap handle in this ISO position isolates certain hydraulically operated components such as the wheel brakes, landing gear, flaps, tailhook, NGS (nose gear steering), and wingfold. When these components are isolated, a valve is closed, preventing hydraulic fluid from flowing to them and thus making actuation impossible.

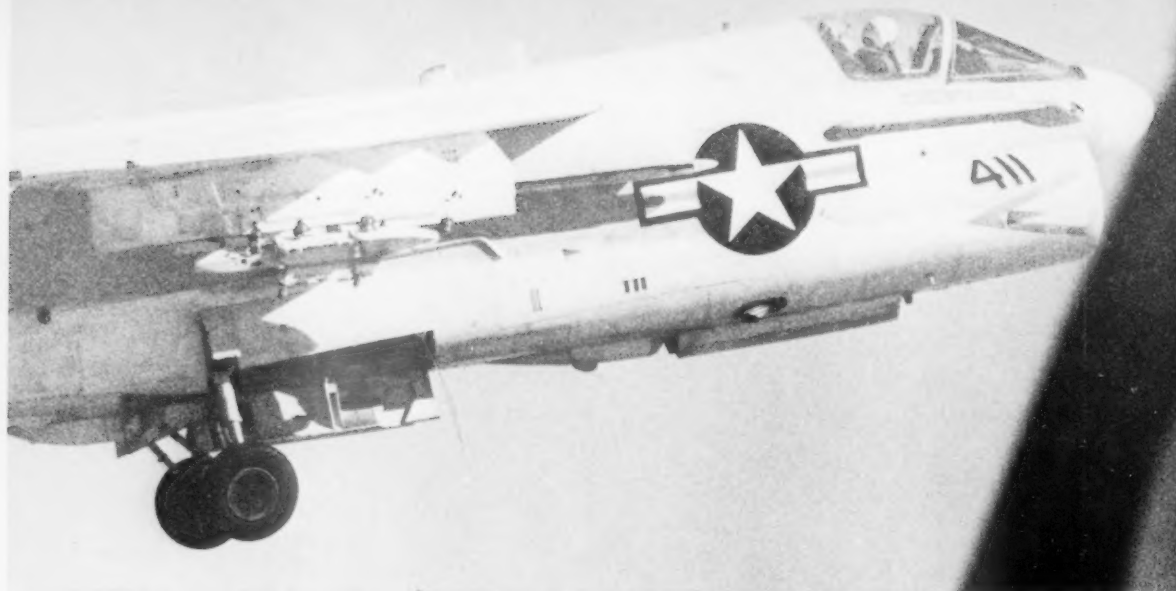
After lowering the gear handle, the pilot inadvertently selected ISO instead of FLAPS DOWN. The photo is of a test aircraft in the same configuration as that of the accident aircraft.

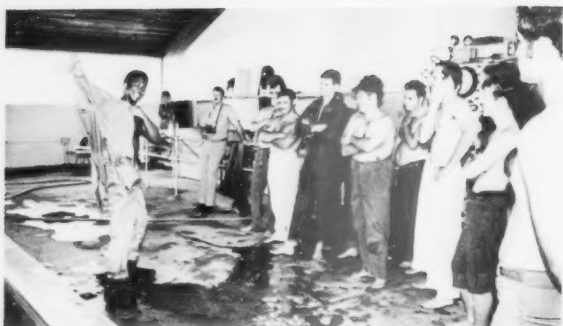
HM3 Johnson, Aviation Physiology, shows the proper procedure for donning a QD1.

As part of the survival problem, the crewmen had only 4 minutes to get out of their LPAs, don the QD-1, get back into the LPA, jump in the water, and board the seven-man rafts. The actual launch of a fully packed raft was a first-time experience for most. The rafts had been purposely overturned so that the crewmembers would have to turn them upright before entering. Righting an overturned seven-man raft is not a difficult task, unless you are in an LPA and QD-1. The men soon discovered how hard it is to swim with the "Gibson Girl" radio, a Channel 15 sonobuoy, or other bulky equipment while in full survival gear. Following the water survival problem, the group received a lecture on the contents of their personal survival gear.

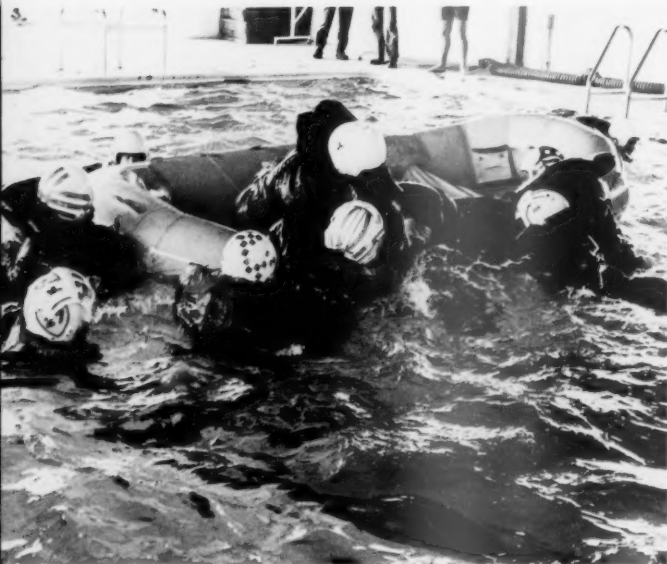
Flightcrew members, having righted the seven-man raft, learn just how difficult it is to board in full survival gear.

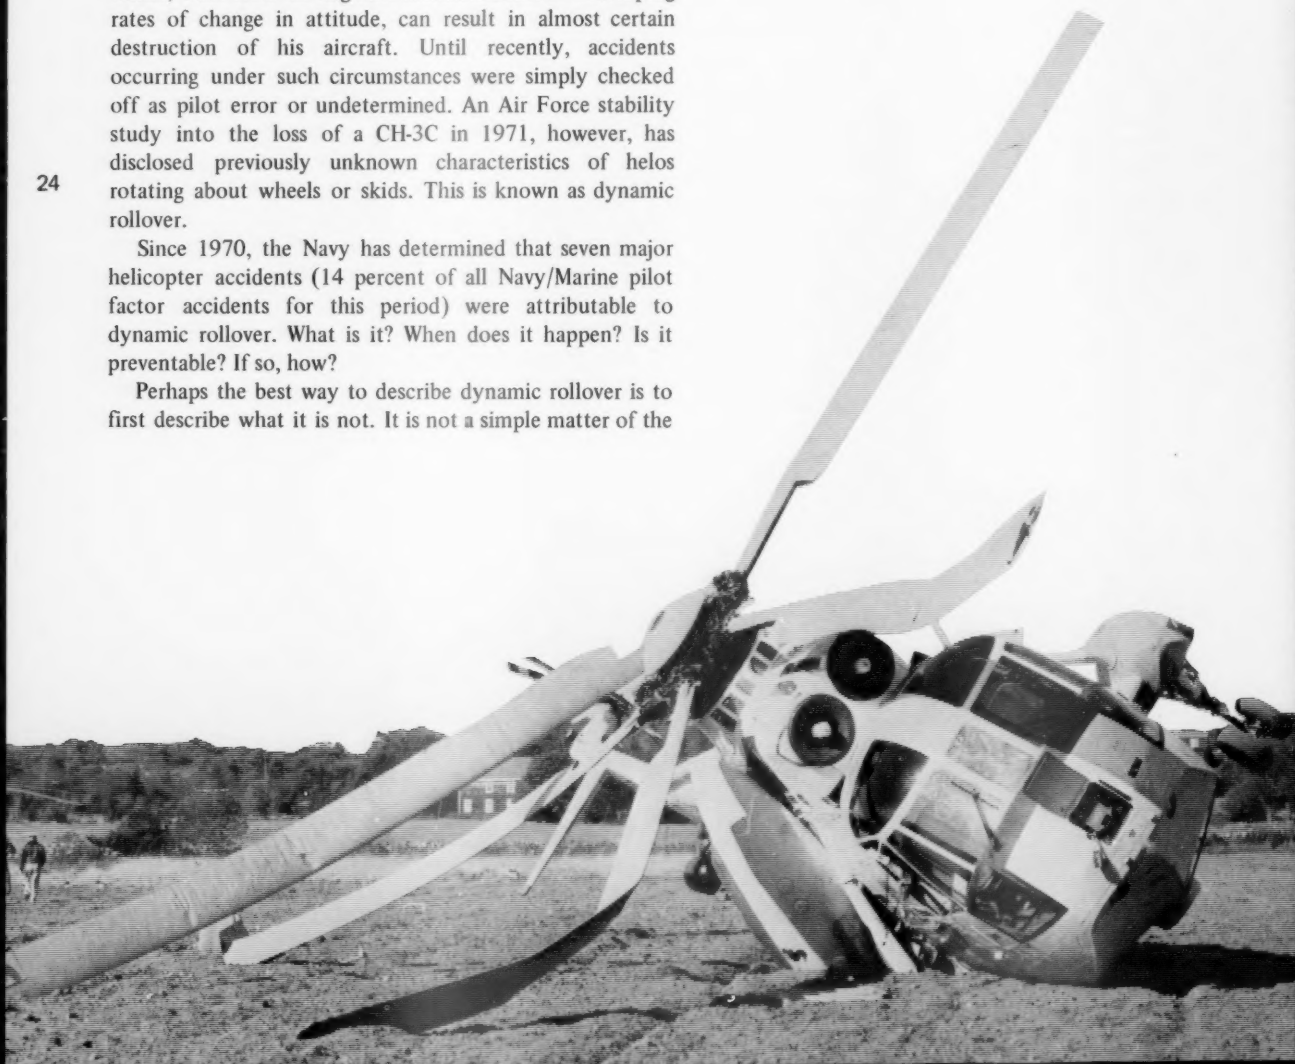
Fig. 1

Aircraft	Static Rollover Angle	Critical Rollover Angle
UH-1	35°	17°
AH-1	33°	15°
SH-2	78°	(Not available)
SH-3	40°	17°
CH-46	(Not available)	(Not available)
CH-53	(Not available)	15°
TH-57	28°	10°

Is dynamic rollover something which results from attempting to land on or depart from a slope in excess of the lateral trim limitation of the aircraft? Clearly, there are slope angles which, although less steep than static rollover angles, are nonetheless beyond the lateral controllability of the aircraft. Therefore, even if the helicopter were plumbed onto such a slope, it would be impossible to raise it to skid (wheel) level for takeoff due to lateral control limits. The angle of slope which would require maximum lateral cyclic input to trim the skids level is often referred to as the "critical rollover angle." (Values of critical rollover angles for some helos are shown in Fig. 1.) By no means must a helicopter exceed or even equal the critical rollover angle before it is committed to dynamic rollover. Thus it would be foolish for the helicopter pilot to consider himself invulnerable to dynamic rollover merely because he hadn't approached the critical rollover angle.

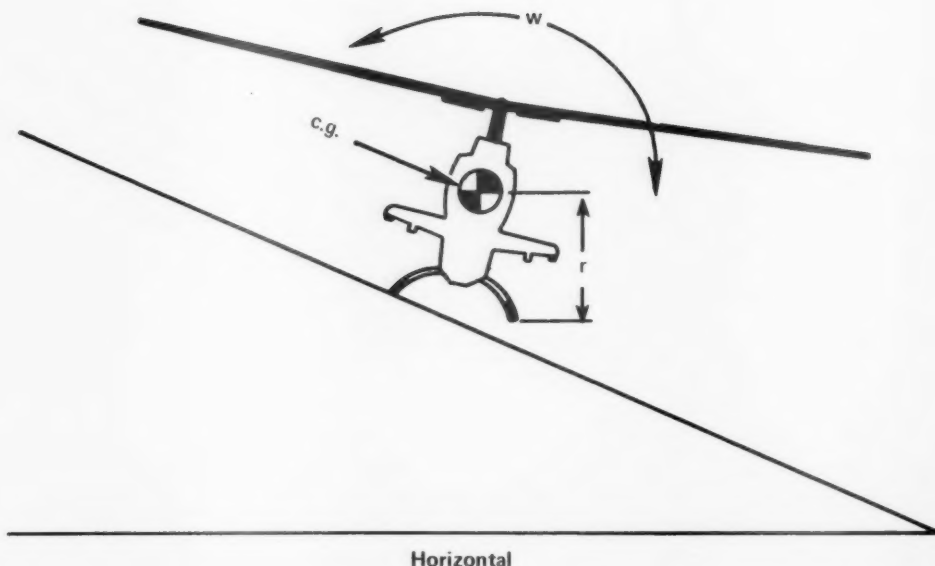
Let's suppose that everything is going against the pilot. The wind is blowing upslope. He's in a high CG, single-rotor helo with a high tail rotor. He's taking off at high gross weight, rotating about the right skid, which is upslope. With full right lateral cyclic, he adds a little too much left rudder and pulls collective a little too abruptly. A roll rate develops upslope, resulting in an angle to the upslope side of the skids level. The pilot counters with full left lateral

cyclic. The upslope roll rate diminishes but doesn't stop. In less than 2 seconds the aircraft will become a statistic unless thrust, a major contributor to the angular roll rate, is rapidly but smoothly reduced. The pilot, being careful not to bounce on the downslope skid, *must reduce collective*. This may allow recovery even though lateral control authority has been exceeded.
